NEW ORLEANS HISTORIC DISTRICT LANDMARKS COMMISSION  
CENTRAL BUSINESS DISTRICT HISTORIC DISTRICT LANDMARKS COMMISSION

Re: 1510 Religious Street

**Permit Number:** 26-08766-HDLC

**Description:** Applicant is requesting retention of multiple deteriorated items and MEP systems at a Landmark, commercial building, work done without a Certificate of Appropriateness.

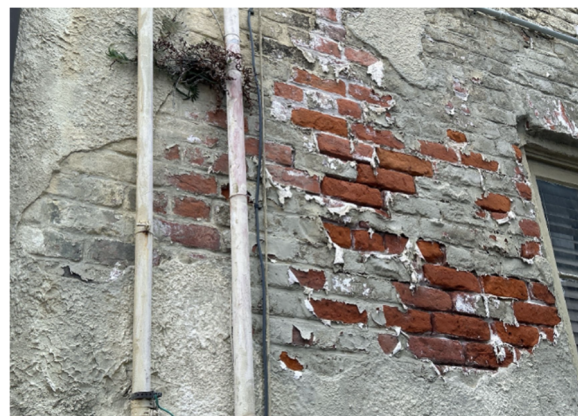
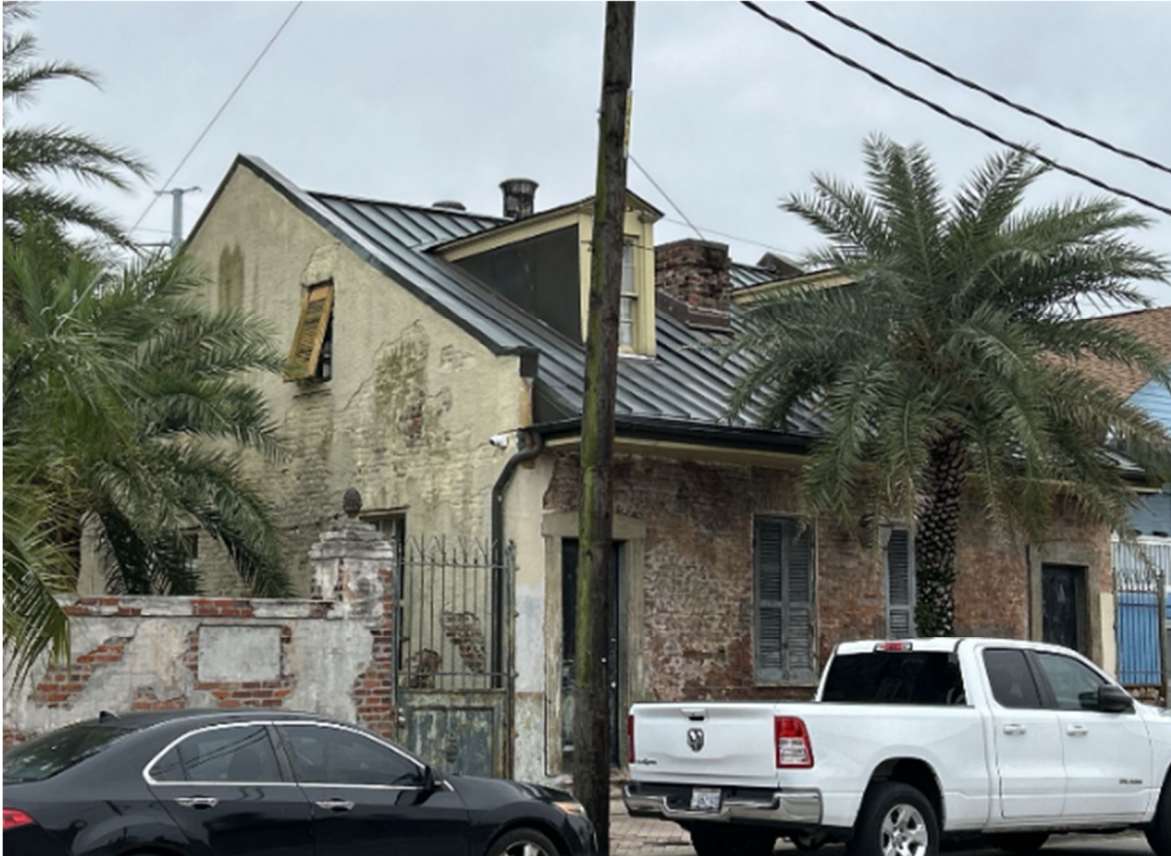
2026

The applicant is requesting the retention of the current condition of the masonry and stucco citing the want to keep the "historic" look of the deterioration. However, the HDLC Guidelines do not allow for maintaining the appearance of delaminated stucco. Further, the brick at this building is soft "lake" brick and shows signs of delamination and missing mortar joints. While staff appreciates the aesthetic concern of the applicant, the main interest of the HDLC in this matter is the level of deterioration of the masonry.

**Unfortunately, this look of deterioration has long been romantically associated with a quaint New Orleans mystique that is understandably appealing to many. However, in reality, it is the result of moisture intrusion and indicates masonry deterioration. If left unaddressed, this can lead to failure of the material which is why this is referred to as “demolition by neglect”, as can be indicated in several recent partial building collapses.** Best practice, would be to repoint all of the

failing and missing mortar joints and have a new coat of an HDLC approved stucco applied to all elevations. Further, photos from the 1990s into the early 2000s show the building completely encapsulated with stucco. Staff recommends denial of the retention to maintain the current level of deterioration of the masonry and stucco and recommends that the mortar be repointed and the delaminated stucco repaired.

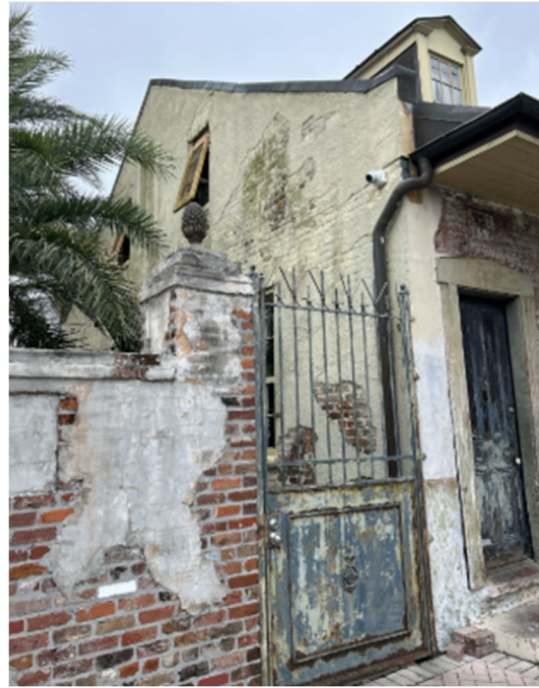
Similar to the masonry, the applicant is requesting retention of the deteriorated metal entry gates at the left and right side of the cottage. The gates are iron and are not only showing a patina but quite a bit of rust. For the longevity and preservation of the gates, staff would recommend sanding and repainting before the deterioration warrants replacement. Staff recommends denial of the retention of the deteriorated entry gates.

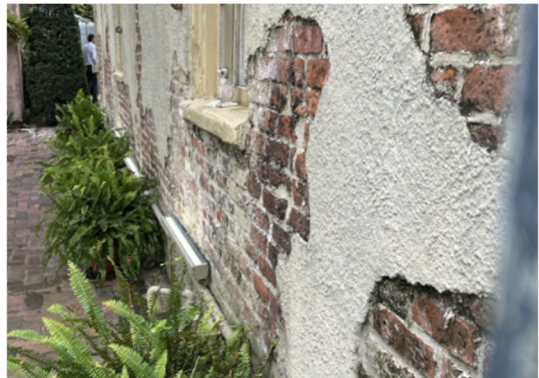
At the ground-level on the left elevation, fluorescent tube uplighting has been installed. These light fixtures do not meet the Guidelines for security lights and are large and intrusive. Further, the Guidelines do not approve fluorescent tube lighting that is visible from the public-right-of-way. Staff recommends denial of the installation of the tube lights and recommends HDLC approved security lights or landscape lighting that is not attached to the building.

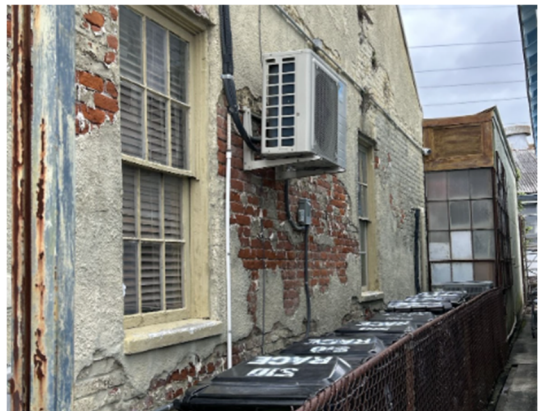
A new visually prominent mini-split has been installed at the right elevation less than 10'-0" from the front wall with highly visible conduit. The Guidelines require any new visible mechanical units, including mini-splits, on a Landmark to be reviewed by the Commission. As the mini-split and conduit is highly visible and does not meet the Guidelines, Staff recommends denial of the current location.
