NEW ORLEANS HISTORIC DISTRICT LANDMARKS COMMISSION  
CENTRAL BUSINESS DISTRICT HISTORIC DISTRICT LANDMARKS COMMISSION

Re: 934 Port Street

## 934 Port Street Appeal Summary

Appeal of the New Orleans HDLC denial of retention of missing stucco as is.

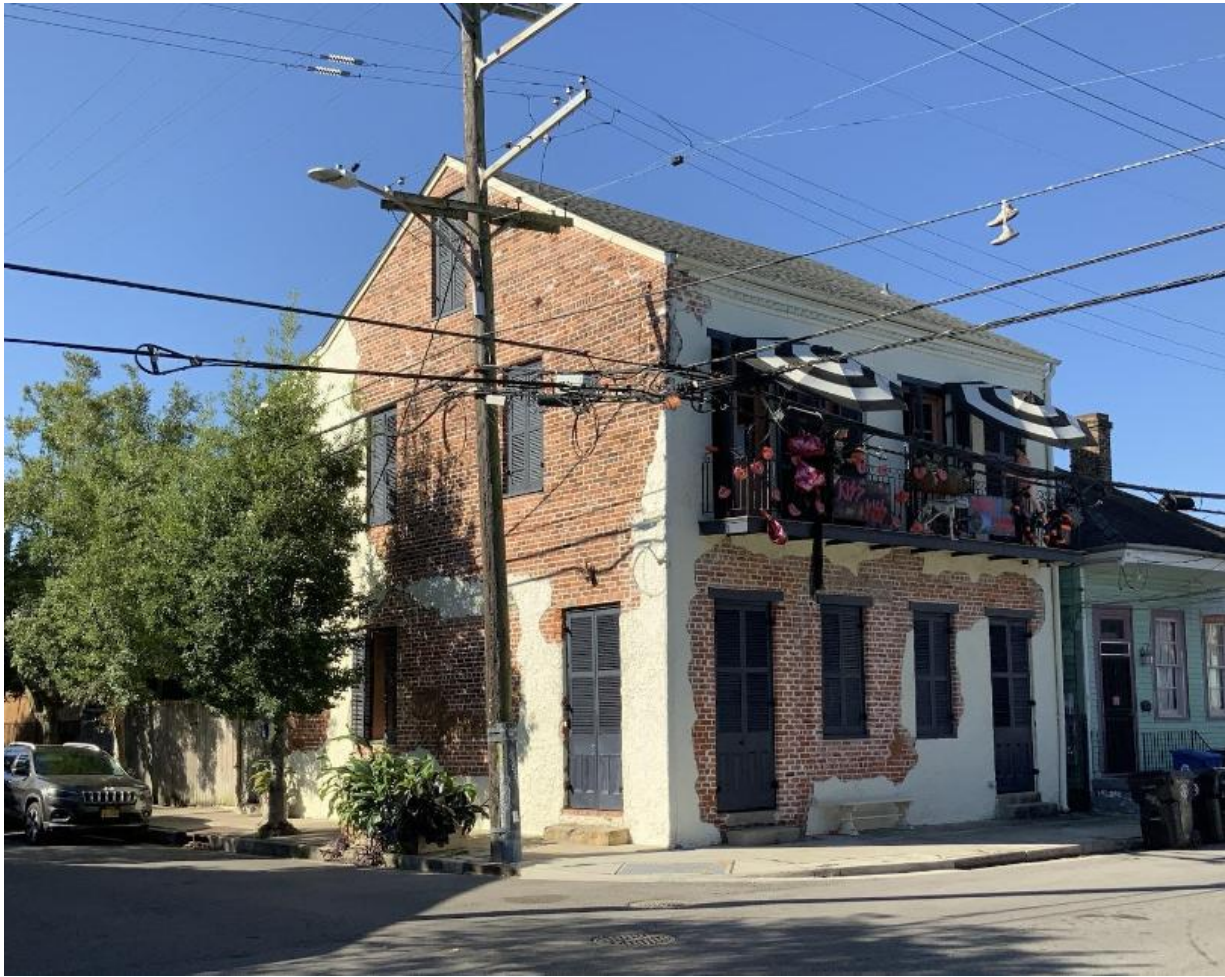
March 26, 2007 – Evidence of beginning of building stucco finish delamination cited by HDLC.

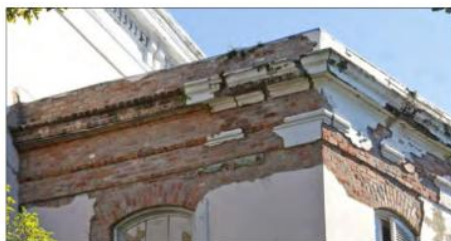
**Stucco removed near roof** – Stucco was often used as a less expensive means of achieving the prominence and grandeur of masonry. In this example, the stucco was scored to resemble stones and molded to form the details of the window surrounds and cornice. The failure of the stucco has exposed the soft, underlying brick to the elements.

**Recommendation** – Verify whether there is a roof drainage issue that caused the stucco to fail. Apply compatible stucco to match historic profiles and finish and lime based masonry paint for a uniform appearance.
