NEW ORLEANS HISTORIC DISTRICT LANDMARKS COMMISSION  
CENTRAL BUSINESS DISTRICT HISTORIC DISTRICT LANDMARKS COMMISSION

Re: 934 Port Street

## 934 Port Street Appeal Summary

Appeal of the New Orleans HDLC denial of retention of missing stucco as is.

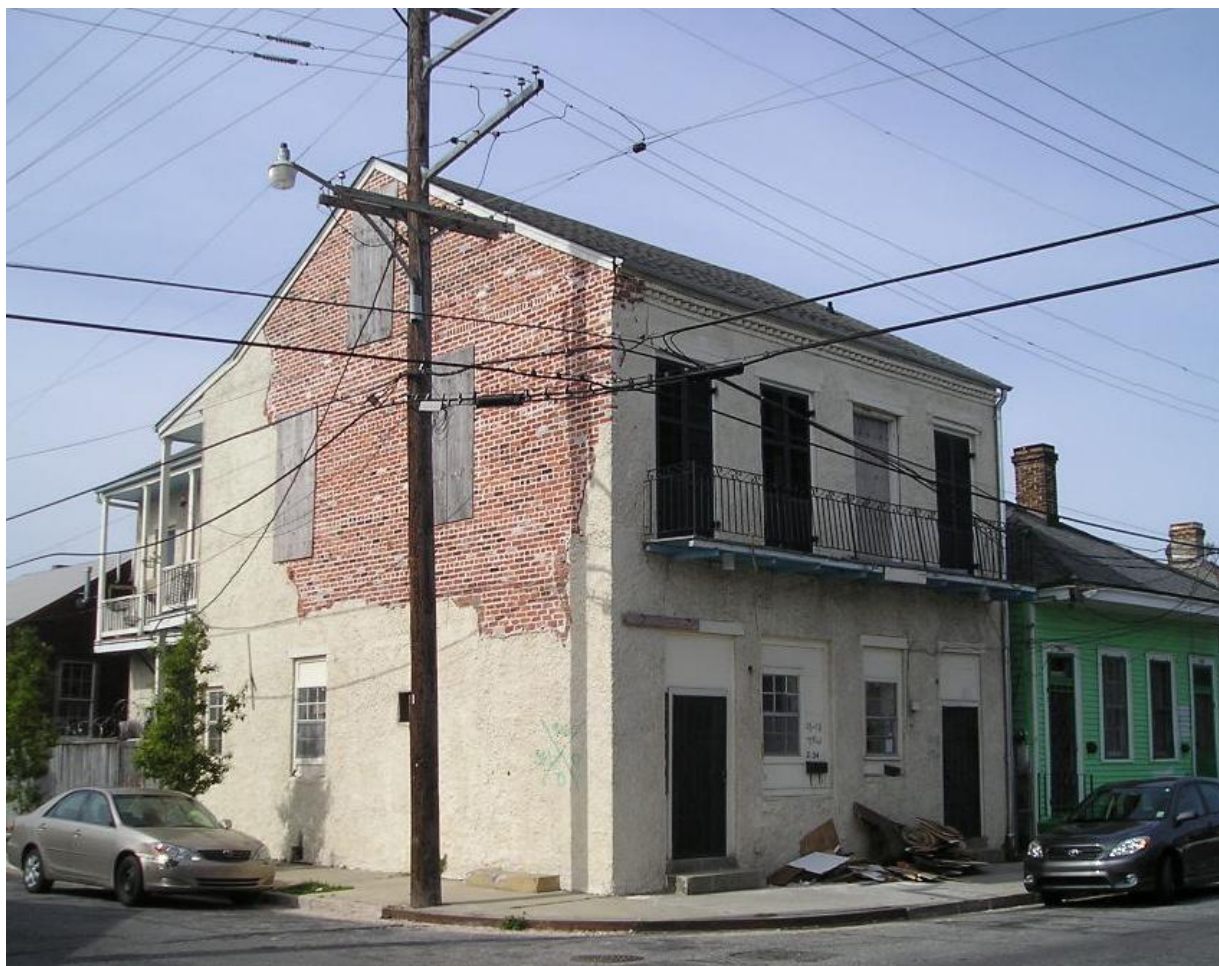
Delaminated stucco leaves bricks exposed to moisture and deterioration.

HDLC has been citing the property for deteriorated and missing stucco since 2013.

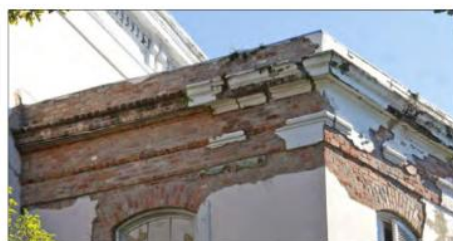
**Stucco removed near roof** – Stucco was often used as a less expensive means of achieving the prominence and grandeur of masonry. In this example, the stucco was scored to resemble stones and molded to form the details of the window surrounds and cornice. The failure of the stucco has exposed the soft, underlying brick to the elements.

**Recommendation** – Verify whether there is a roof drainage issue that caused the stucco to fail. Apply compatible stucco to match historic profiles and finish and lime based masonry paint for a uniform appearance.
