FW: APPEAL REQUEST FOR DEMO: 4854 Camp St.

4854 Camp St.

Description: Demolition of a Contributing but altered one-story, single-family residential building to grade.

4854 Camp St. Demolition Request Inspection Results

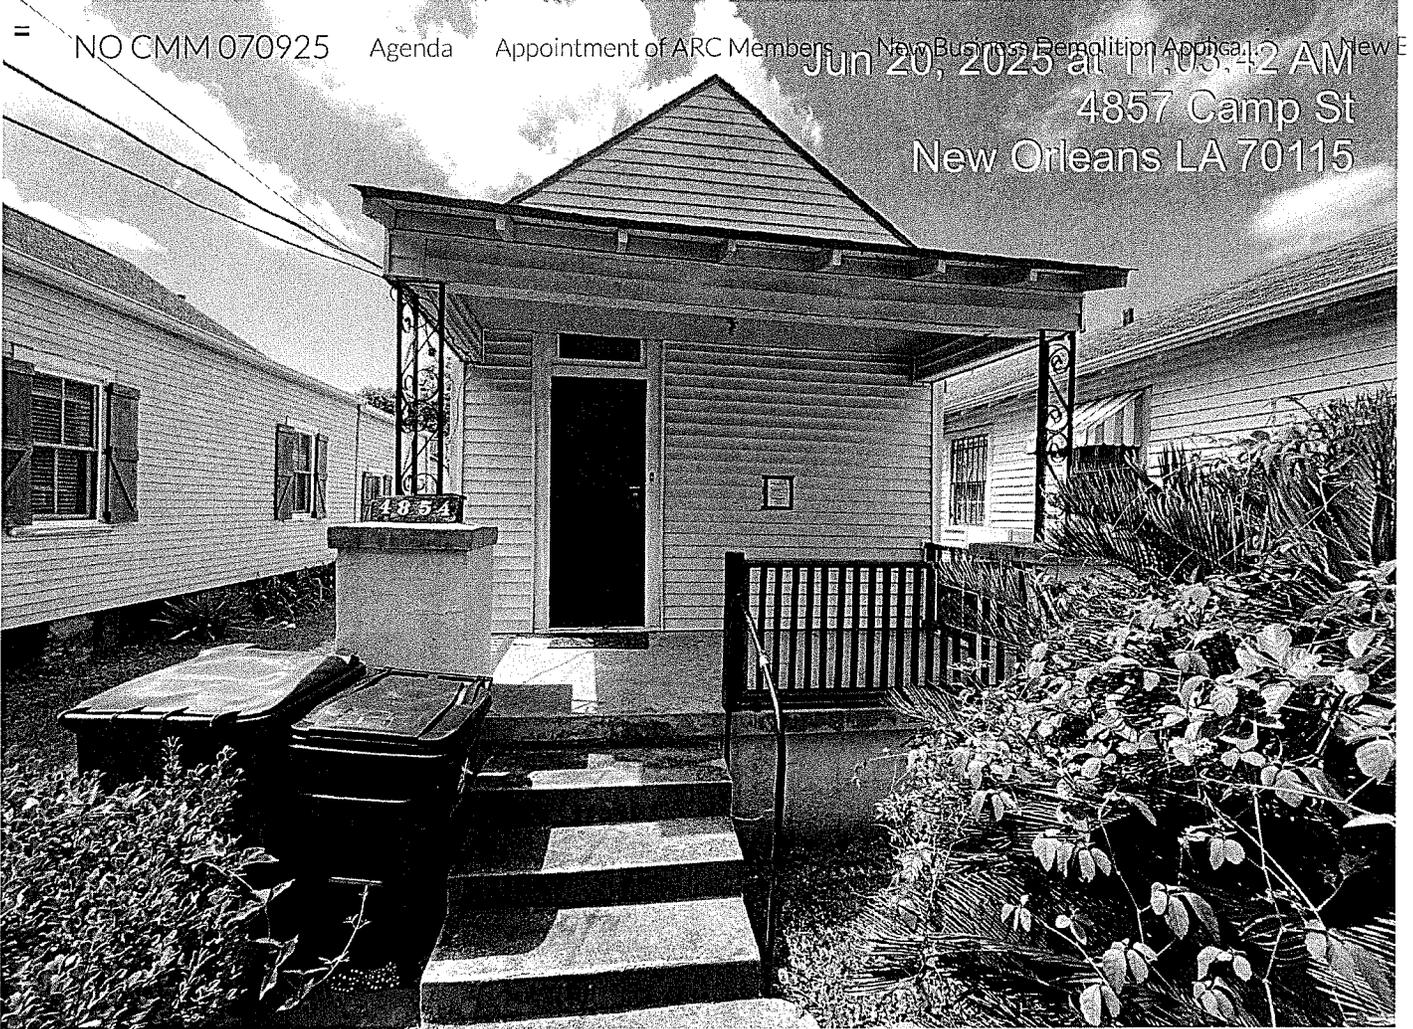
Exterior Inspection Photos:

- **The condition of the building or structure:** An exterior and interior inspection was conducted on June 20, 2025. The building appeared to be in good structural condition. The stick framed building sits atop masonry piers with an asphalt shingle roof. Vegetation was present on part of the roof and chimney.

The building is clad in vinyl siding presumably encapsulating wood weatherboards. The primary elevation retains little of it's architectural elements while the sides retain the typical shotgun fenestration pattern with wood trim and vinyl windows. The building was plumb and level and did not have outward signs of wood destroying insect. Gutters and downspouts were present at the building. In some locations the gutters would need to be removed to install proper flashing. The masonry piers and subfloor were intact and bearing the load of the building.

Staff believes this is an excellent candidate for rehabilitation due to the relatively intact nature of the interior and the minimal intervention required to restore the front elevation. Fore the aforementioned reasons Staff recommends denial.

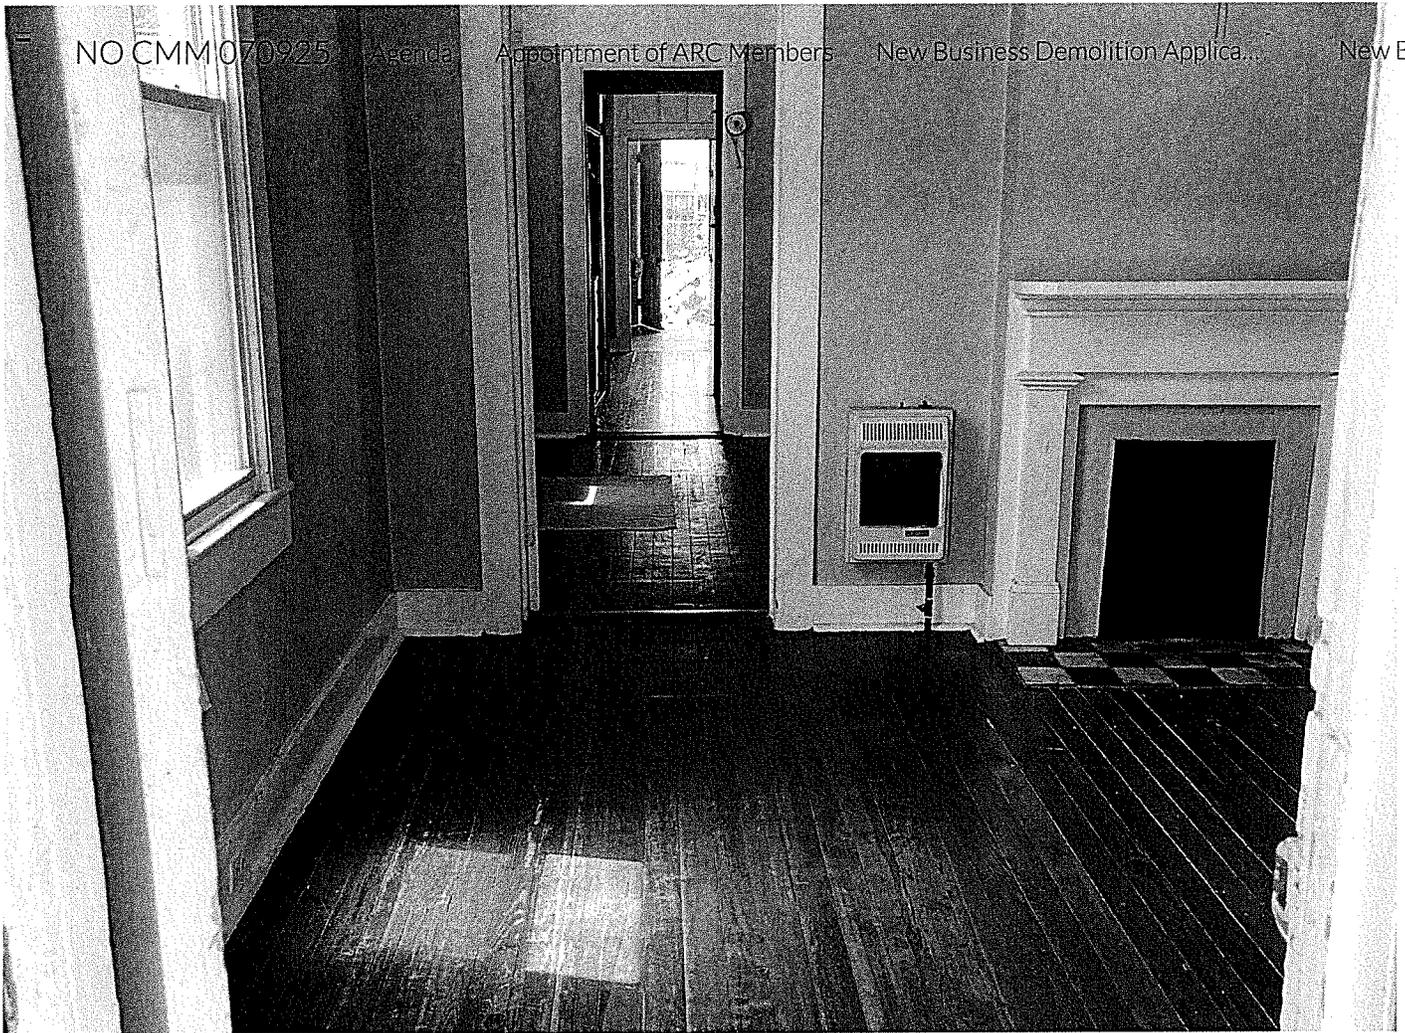
Interior Inspection Photos:

The interior of the building is currently not occupied. The interior layout is truly a single shotgun layout as evidenced by it's concentric doorways. The wood floors in the main portion of the building appear to be original and are wider than more narrow plank flooring see in Craftsman style home. The fire place surrounds and mantels that are intact also allude to the building being older. There were no visible signs of wood destroying insects however there were signs of water intrusion. The water intrusion is most likely caused by the flashing condition noted above. The rear shed addition of the building houses the kitchen and bathroom and is in very poor condition.

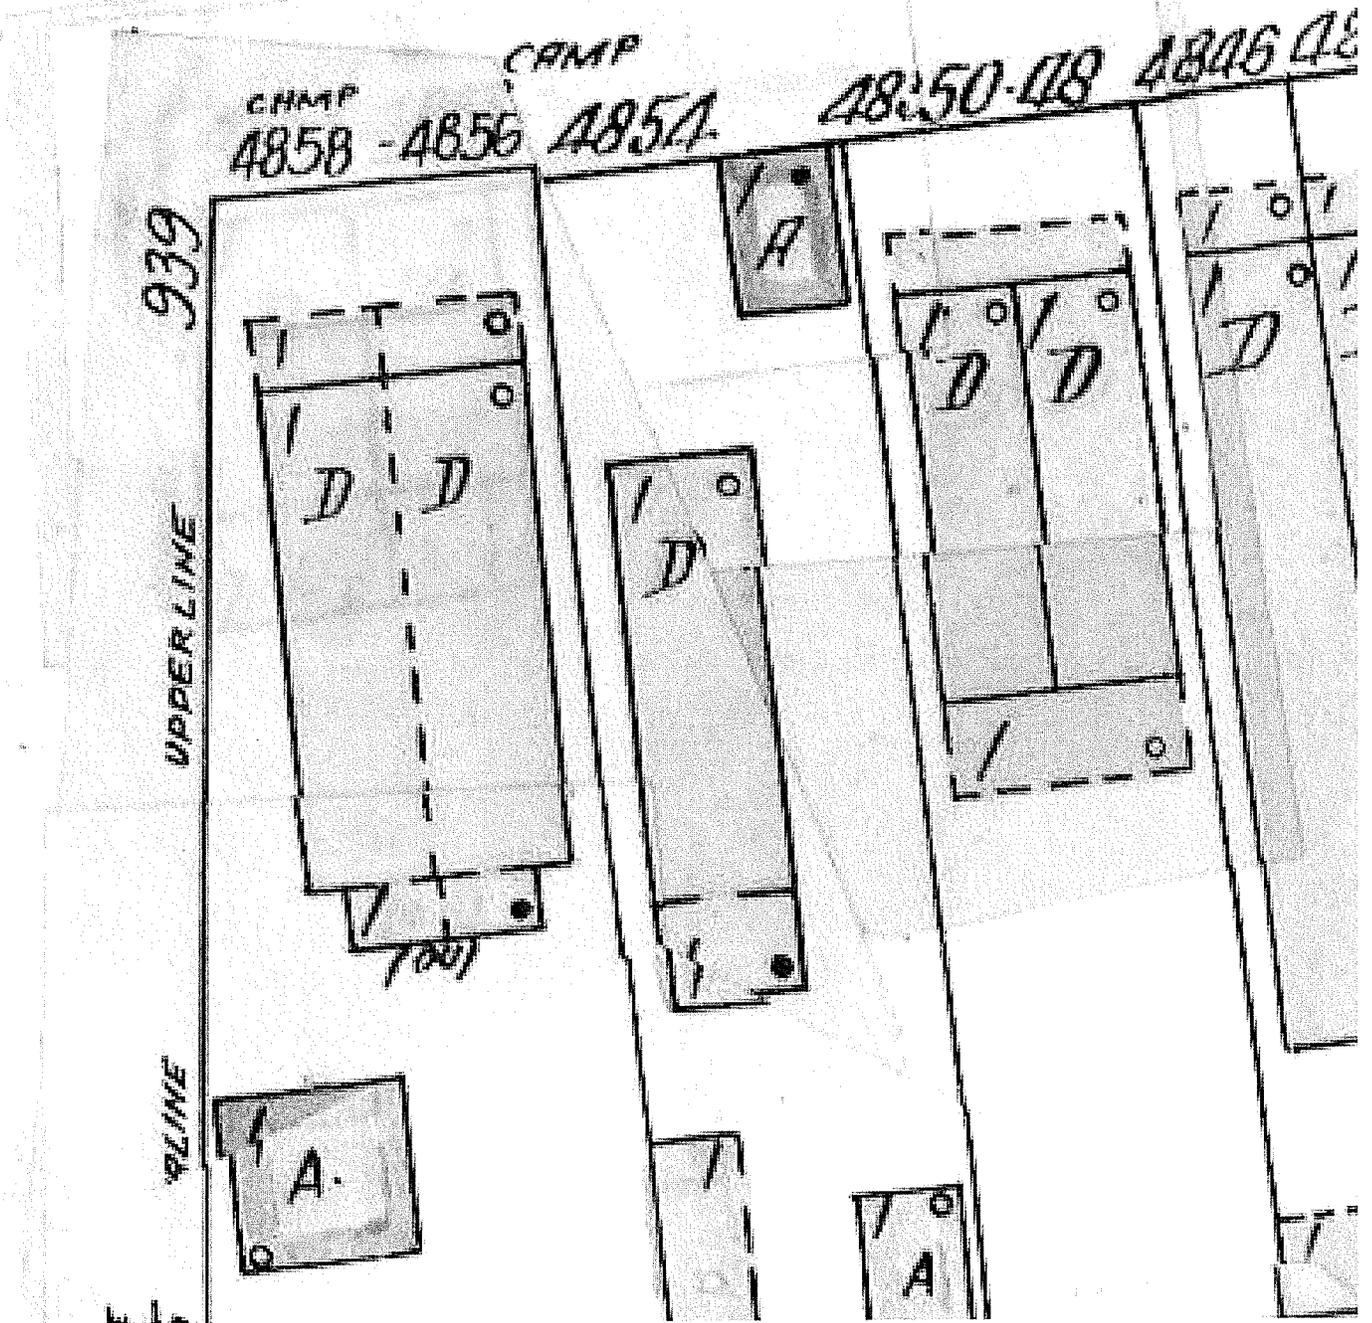
Sanborn Maps:

- **The historic or architectural significance of the building or structure as designated by its "rating":** Contributing
- **The importance of the building or structure to the tout ensemble of the area:** FEMA survey research estimates that 4854 Camp was constructed from 1925-1935 but does not appear on the Sanborn map until 1951. The single shotgun building sits perched further back from it's neighboring buildings. Sanborn research indicates that a single shotgun has resided on this parcel as far back as 1896. It does not appear that the siting of the current is congruent with the 1896 siting but the massing and interior finishes are indicative of a building of the late 19th century.

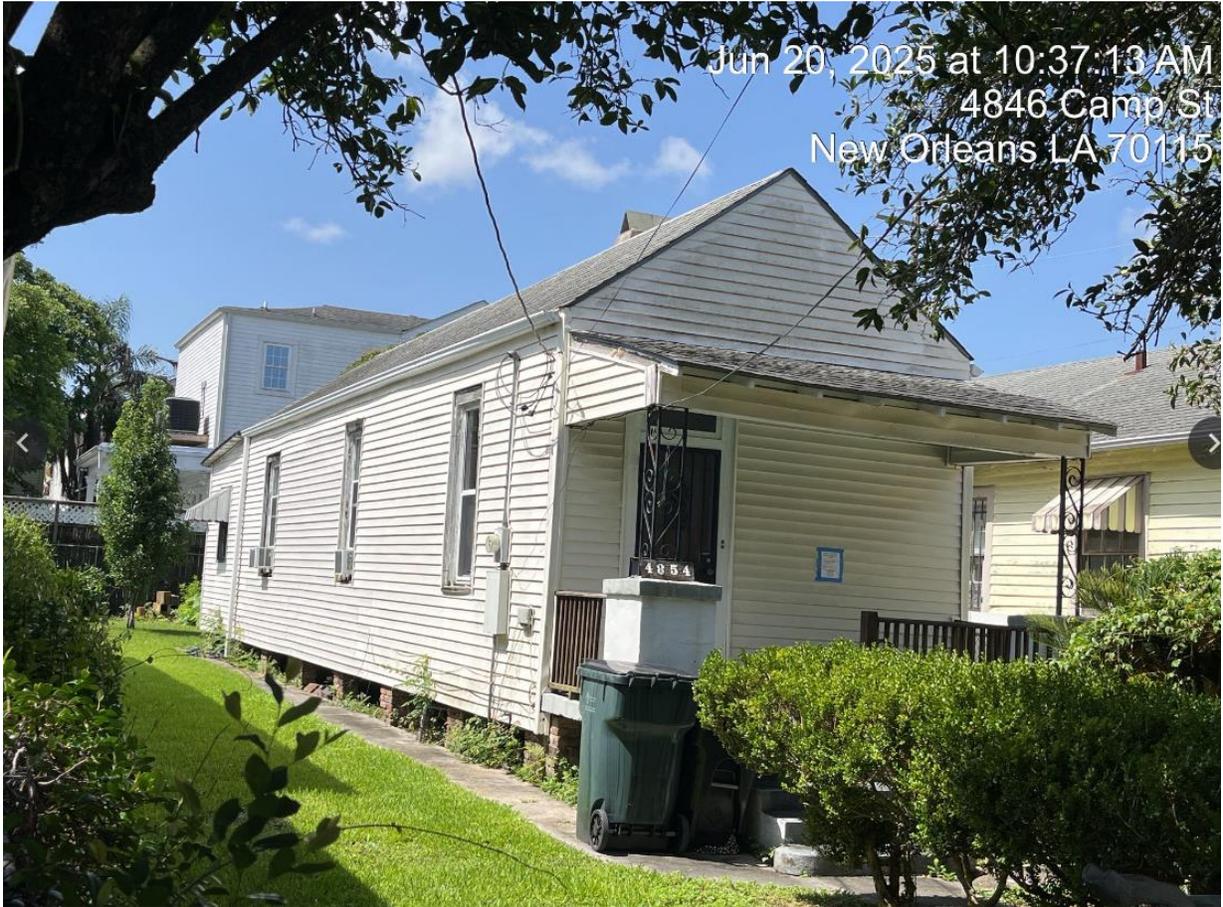
- **The alternatives to demolition that have been explored by the applicant:** New Construction
- **The difficulty or impossibility of reproducing such a building or structure because of its design, texture, material or detail:** It would not be cost prohibitive to recreate a building of this size or massing but replication of the remaining interior finishes and fenestration pattern would be highly unlikely.
- **The condition of the building or structure:** An exterior and interior inspection was conducted on June 20, 2025. The building appeared to be in good structural condition. The stick framed building sits atop masonry piers with an asphalt shingle roof. Vegetation was present on part of the roof and chimney.

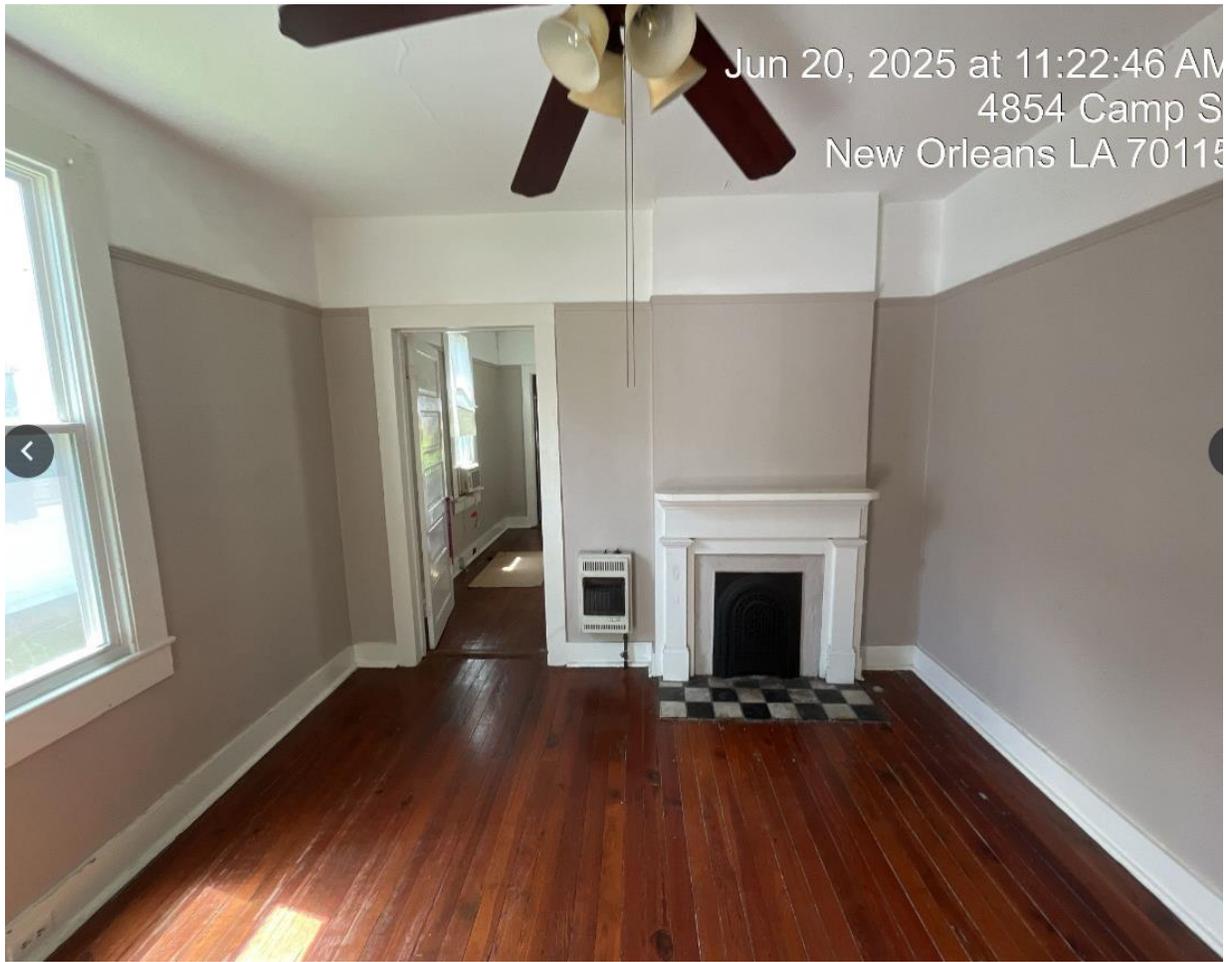
The interior of the building is currently not occupied. The interior layout is truly a single shotgun layout as evidenced by its concentric doorways. The wood floors in the main portion of the building appear to be original and are wider than more narrow plank flooring. The fireplace surrounds and mantels reflect late 19th century construction methods. There are no visible signs of wood destroying insects however there were signs of water intrusion. The water intrusion is most likely caused by the flashing condition noted above. The non-original shed roof addition at the rear of the building houses the kitchen and bathroom and is in very poor condition.

Staff believes this is an excellent candidate for rehabilitation due to the relatively intact nature of the interior and the minimal intervention required to restore the front elevation. For the aforementioned reasons, Staff recommended denial.

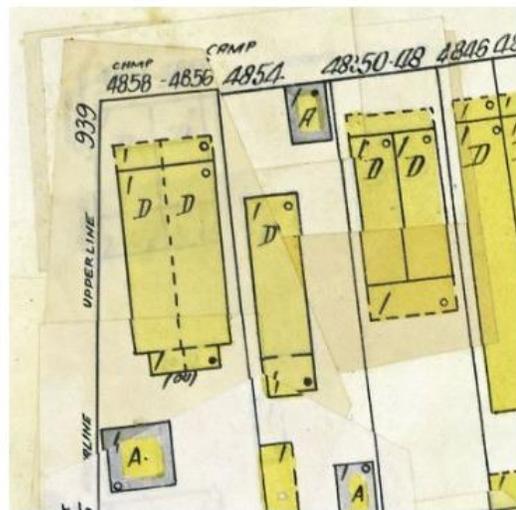
Sanborn Maps:

- **The historic or architectural significance of the building or structure as designated by its “rating”:** Contributing
- **The importance of the building or structure to the tout ensemble of the area:** FEMA survey research estimates that 4854 Camp was constructed from 1925-1935 but does not appear on the Sanborn map until 1951. The single shotgun building sits perched further back from its neighboring buildings. Sanborn research indicates that a single shotgun has resided on this parcel as far back as 1896. It does not appear that the siting of the current is congruent with the 1896 siting but the massing and interior finishes are indicative of a building of the late 19th century.

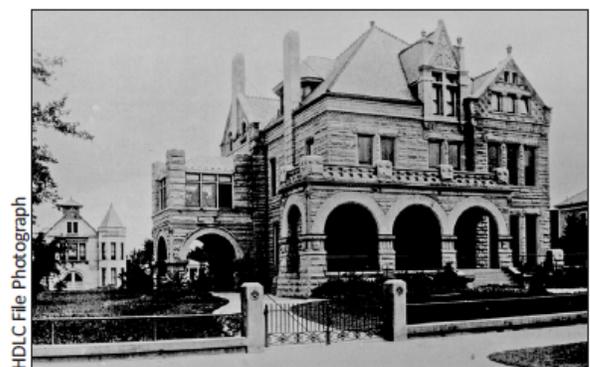
HDLC File Photograph

The Isidore Newman House, constructed in 1890, designed by Thomas Sully, was demolished in 1972. Its demolition galvanized the organization of what is now known as the St. Charles Avenue Association, and the push for preservation ordinances to protect historic districts.
