NEW ORLEANS HISTORIC DISTRICT LANDMARKS COMMISSION  
CENTRAL BUSINESS DISTRICT HISTORIC DISTRICT LANDMARKS COMMISSION

Re: 1510 Religious Street

**Permit Number:** 26-08766-HDLC

**Description:** Applicant is requesting retention of multiple deteriorated items and MEP systems at a Landmark, commercial building, work done without a Certificate of Appropriateness.

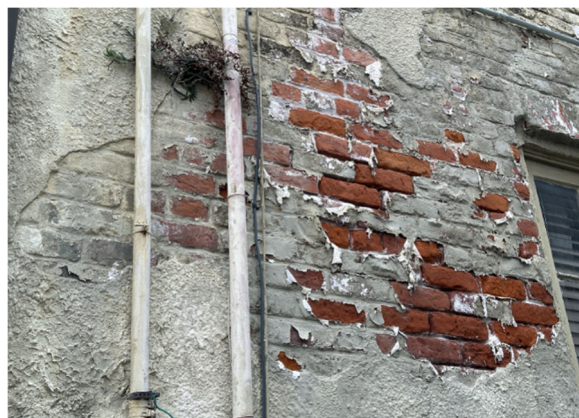
The applicant is requesting the retention of the current condition of the masonry and stucco citing the want to keep the "historic" look of the deterioration. However, the HDLC Guidelines do not allow for maintaining the appearance of delaminated stucco. Further, the brick at this building is soft "lake" brick and shows signs of delamination and missing mortar joints. While staff appreciates the aesthetic concern of the applicant, the main interest of the HDLC in this matter is the level of deterioration of the masonry.

**Unfortunately, this look of deterioration has long been romantically associated with a quaint New Orleans mystique that is understandably appealing to many. However, in reality, it is the result of moisture intrusion and indicates masonry deterioration. If left unaddressed, this can lead to failure of the material which is why this is referred to as “demolition by neglect”, as can be indicated in several recent partial building collapses.** Best practice, would be to repoint all of the

failing and missing mortar joints and have a new coat of an HDLC approved stucco applied to all elevations. Further, photos from the 1990s into the early 2000s show the building completely encapsulated with stucco. Staff recommends denial of the retention to maintain the current level of deterioration of the masonry and stucco and recommends that theC mortar be repointed and the delaminated stucco repaired.

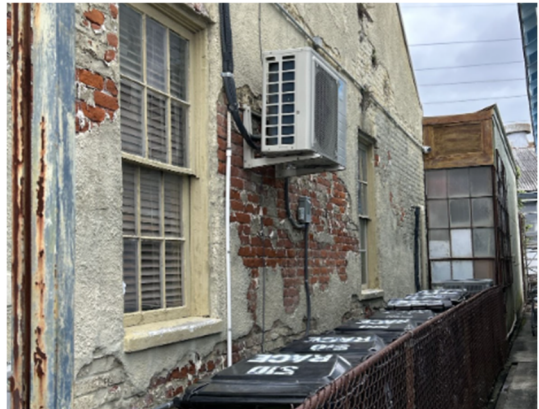
### **Mini-Split**

A new visually prominent mini-split has been installed at the right elevation less than 10'-0" from the front wall with highly visible conduit. The Guidelines require any new visible mechanical units, including mini-splits, on a Landmark to be reviewed by the Commission. As the mini-split and conduit is highly visible and does not meet the Guidelines, Staff recommends denial of the current location.
