NEW ORLEANS HISTORIC DISTRICT LANDMARKS COMMISSION  
CENTRAL BUSINESS DISTRICT HISTORIC DISTRICT LANDMARKS COMMISSION

Re: 934 Port Street

## 934 Port Street Appeal Summary

Appeal of the New Orleans HDLC denial of retention of missing stucco as is.

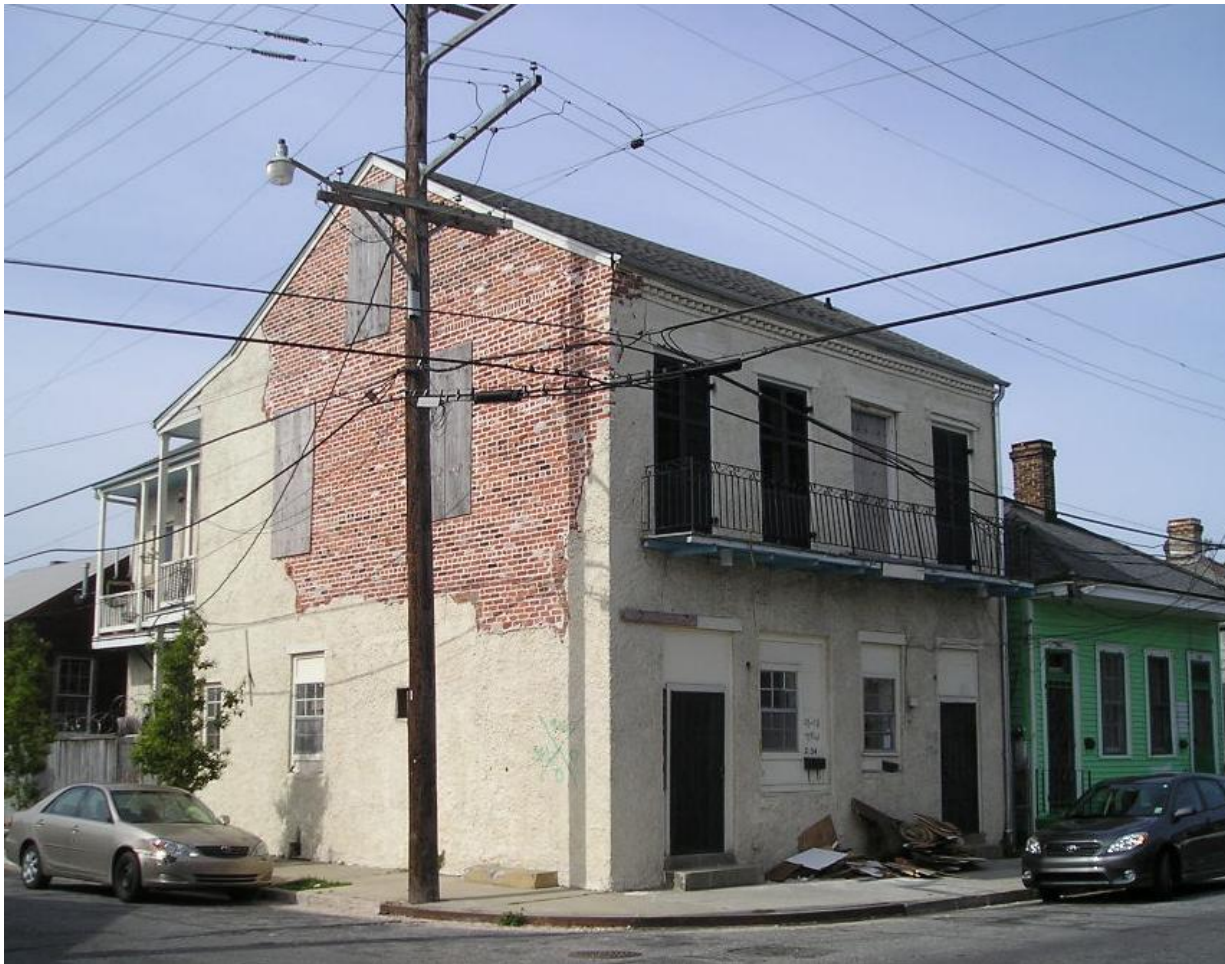
Delaminated stucco leaves bricks exposed to moisture and deterioration.

HDLC has been citing the property for deteriorated and missing stucco since 2013.

March 26, 2007 – Evidence of beginning of building stucco finish delamination cited by HDLC.

Based on these factors and the observable building conditions, Staff recommends denial of the request to retain the delaminated stucco. To address the conditions moving forward, Staff recommends:

- Maintaining the existing spatterdash stucco where it remains in fair to good condition, primarily at the attached rear dependency (shown with blue lines on diagram).
- Applying a new smooth-finish stucco coating only to areas of missing stucco at the N Rampart and Port Street sides (shown with red lines on diagram).
