NEW ORLEANS HISTORIC DISTRICT LANDMARKS COMMISSION
CENTRAL BUSINESS DISTRICT HISTORIC DISTRICT LANDMARKS COMMISSION

Re: 510 Race Street

Attached, please find a report regarding an appeal of the New Orleans Historic District Landmarks Commission's denial of the retention of deteriorated masonry and stucco at a Landmark, commercial building.

Description: Applicant is requesting retention of deteriorated masonry and stucco

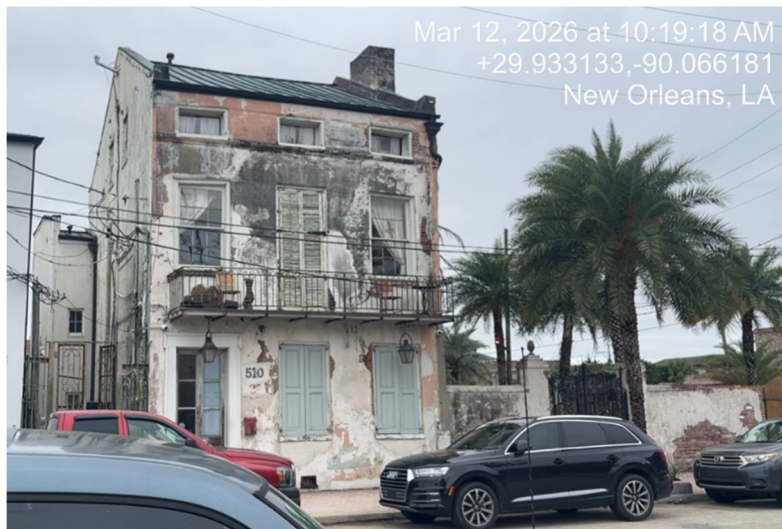
The applicant is requesting the retention of the current condition of the masonry and stucco citing the want to keep the "historic" look of the deterioration. However, the HDLC Guidelines do not allow for maintaining the appearance of delaminated stucco. Further, the brick at this building is soft "lake" brick and is showing signs of delamination, powdering, and missing mortar joints. While staff appreciates the aesthetic concern of the applicant, the main

interest of the HDLC in this matter is the level of deterioration of the masonry. **Unfortunately, this look of deterioration has long been romantically associated with a quaint New Orleans mystique that is understandably appealing to many. However, in reality, it is the result of moisture intrusion and indicates masonry deterioration. If left unaddressed, this can lead to failure of the material which is why this is referred to as “demolition by neglect”, as can be indicated in several recent partial building collapses.** Best practice, would be to repoint all of the failing and missing mortar joints and have a new coat of an HDLC approved stucco applied to all elevations. However, we cannot require that the exposed masonry on the right and rear elevations that do not have a history of being encapsulated with stucco have a new coat of stucco, though Staff would recommend it. Staff

recommends denial of the retention to maintain the current level of deterioration of the masonry and stucco and recommends that at least the mortar is repointed and the delaminated stucco repaired.
