NEW ORLEANS HISTORIC DISTRICT LANDMARKS COMMISSION
CENTRAL BUSINESS DISTRICT HISTORIC DISTRICT LANDMARKS COMMISSION

Re: 1413 Columbus Street

1413 Columbus Street Appeal Summary

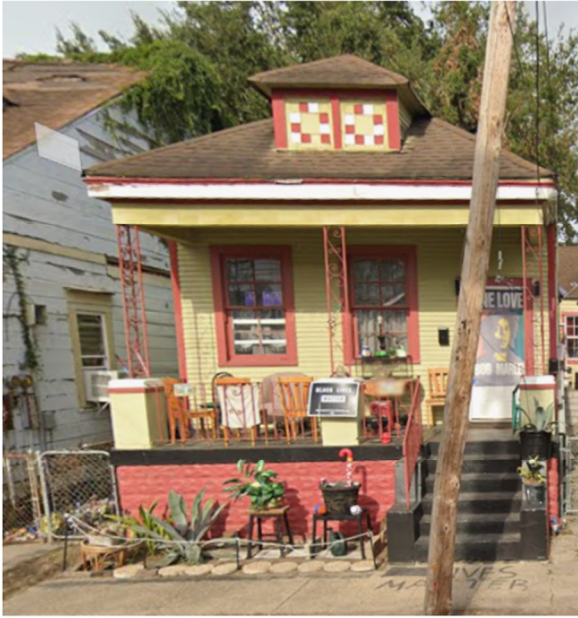
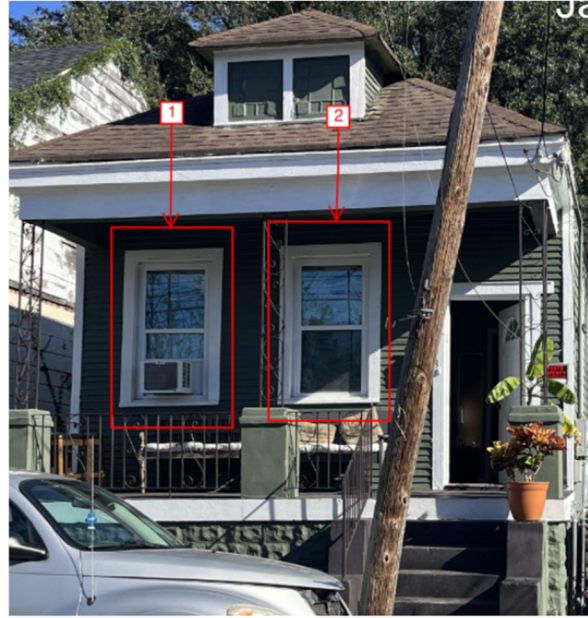
Appeal of the New Orleans HDLC denial of retention of the of the installation of inappropriate windows on the façade (numbered 1,2 on the photos below) and left side (numbered 3,4,5,6 on the photos below) due to their high visibility and because they do not match the original wood windows in profile, muntin pattern, or configuration.

A staff inspection on January 16, 2025 established that there was exterior work done on the building located at 1413 Columbus Street without permits or a Certificate of Appropriateness. At this time, staff found that original wood windows had been removed and inappropriate windows had been installed at all visible elevations.

Staff respectfully request that the City Council uphold the decision of the Historic District Landmarks Commission to deny the retention of inappropriate windows at the front façade (1,2) and left elevation (3,4,5,6) but allow the retention of windows on the right elevation (7,8) with the proviso that wood screens be installed to minimize their visibility.

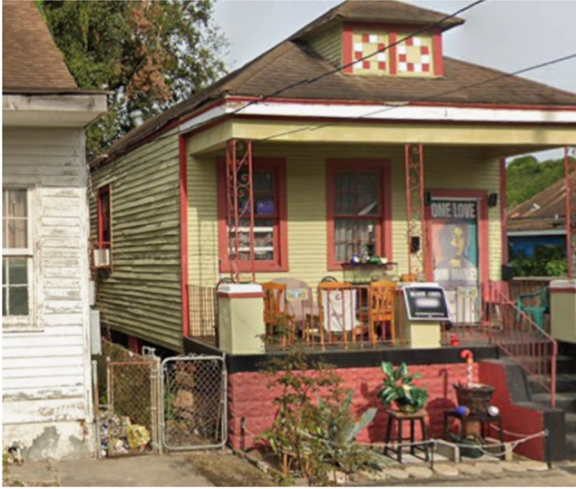
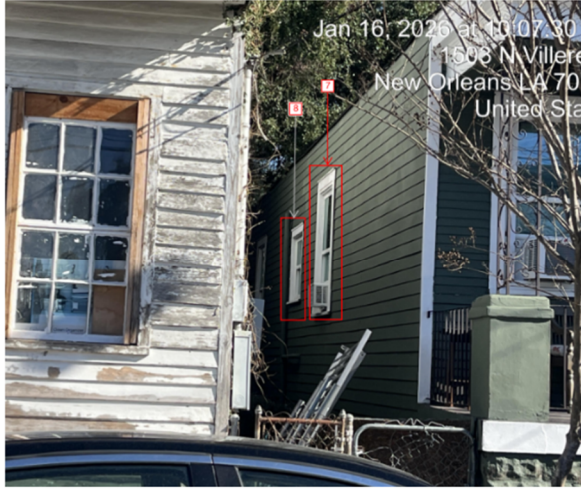
The Commission voted to allow retention of the right side windows (numbered 7,8 on photos below) with the proviso that full screens are added, as they are the least visible from the public right-of-way.
